**Assessment of the Impacts of Various Grazing Management Strategies on
Southern Minnesota Stream Channels**

A THESIS
SUBMITTED TO THE FACULTY OF
THE UNIVERSITY OF MINNESOTA
BY

MAY 2018

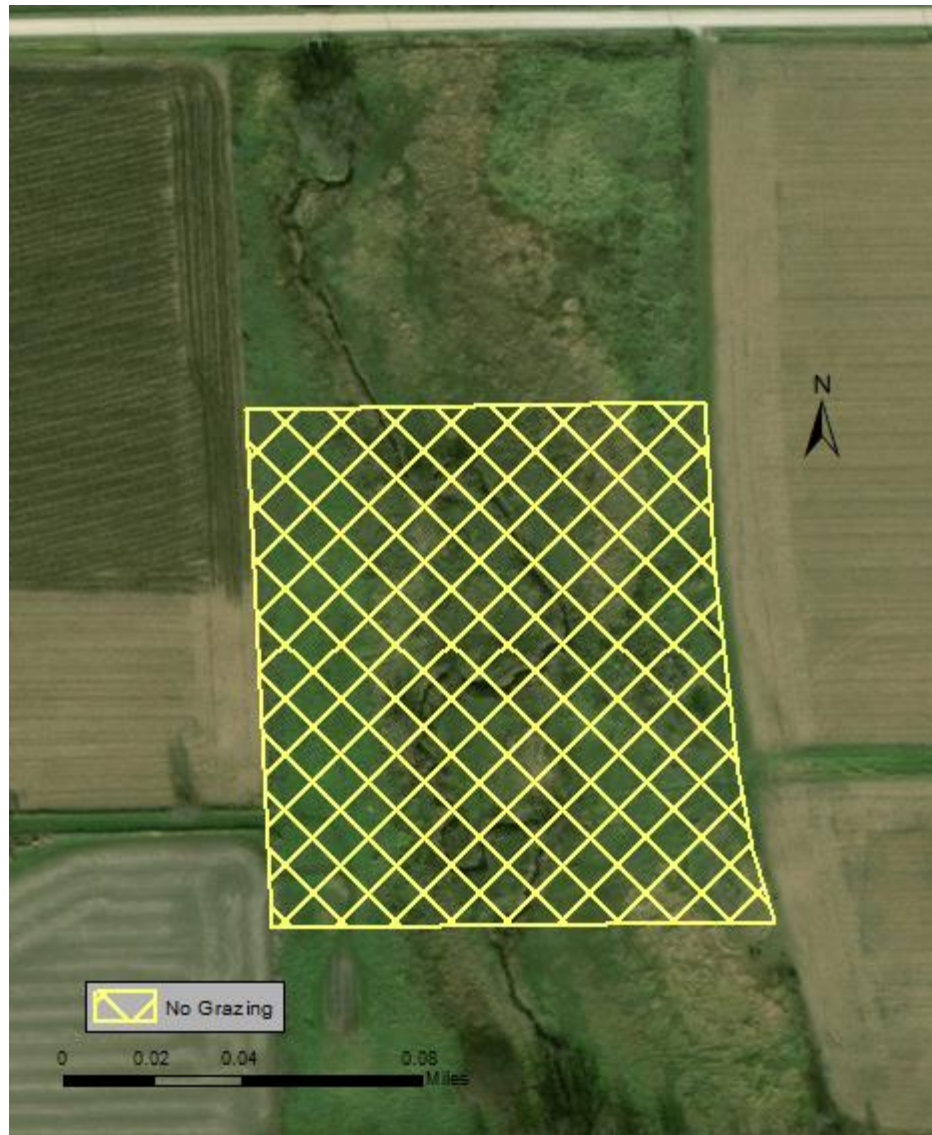
Figure 3.3. Reference reach of Dobbins Creek.

The reference reach is further northeast and upstream of the 600th Ave reach. This has historically been non-grazed. It was surveyed by the DNR in May of 2017 and was used as the best available reference reach for stream projects in the region. Geomorphological survey data was available in RIVERMorph.

Two properties along Dobbins Creek are included in this study; the 600th Ave site and the reference site (Figures 3.2 and 3.3). The 600th Ave site is split into three sections; the northern and middle sections are CG while the southern section is wooded and NG (Appendix J.1). While the middle section is generally grazed about one month less than the northern section each year, no significant disparity was found between the two CG sections. The CG areas were observed to have little vegetative cover and low vegetative diversity, with most of the area being populated by sedges and nettles (Photos J.1.7 and J.1.8). Many of the banks were bare and the channel bed consisted mostly of silt and sand (Photos J.1.5 and J.1.6). At several spots along the sections, the banks had collapsed due to livestock crossing the stream and many other areas were observed to be trampled and the soil compacted (Photo J.1.4).

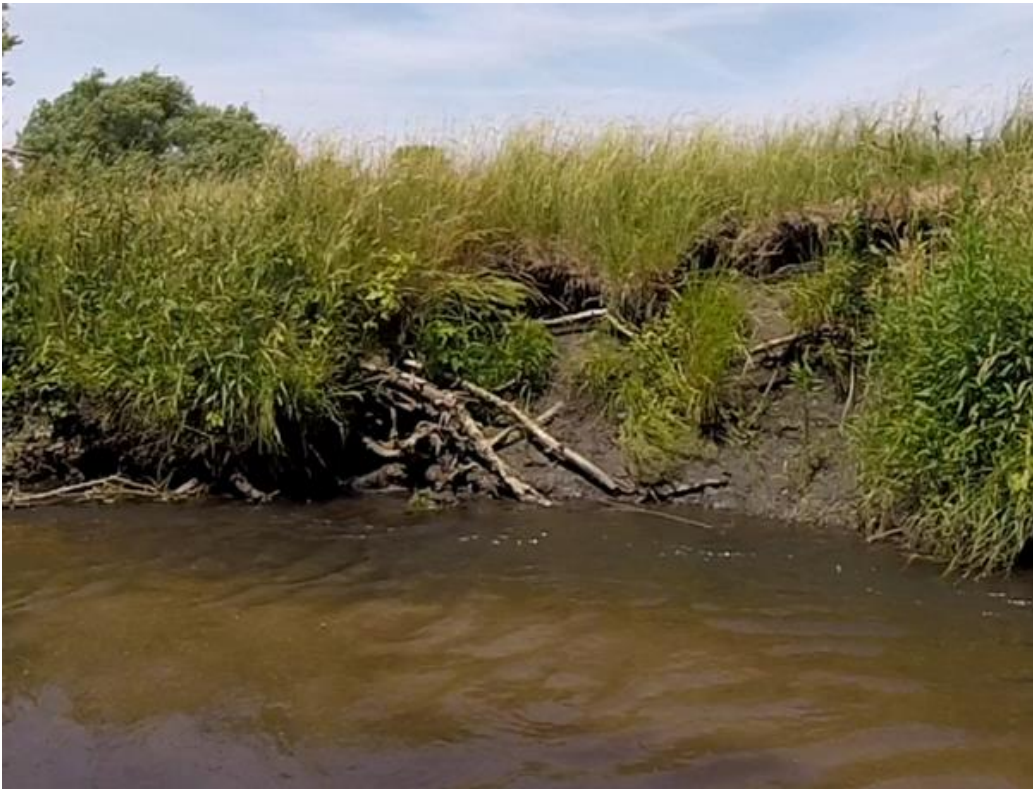
Photo J.1.4. Summer view of a bank in the northern section (Reach 2).
